Bio Topic

Integrated Erosion Control (IEC) Measures

The Programme “Integrated Biodiversity Management, South Caucasus (IBiS)” was financed by the German Federal Ministry for Economic Cooperation and Development (BMZ). One of the objectives of IBiS was to contribute to erosion reduction and rehabilitation of degraded sites in Tusheti by implementing various measures, such as afforestation or bioengineering. In Jvarboseli, several integrated erosion control measures were carried out to stabilise a steep erosion gully.

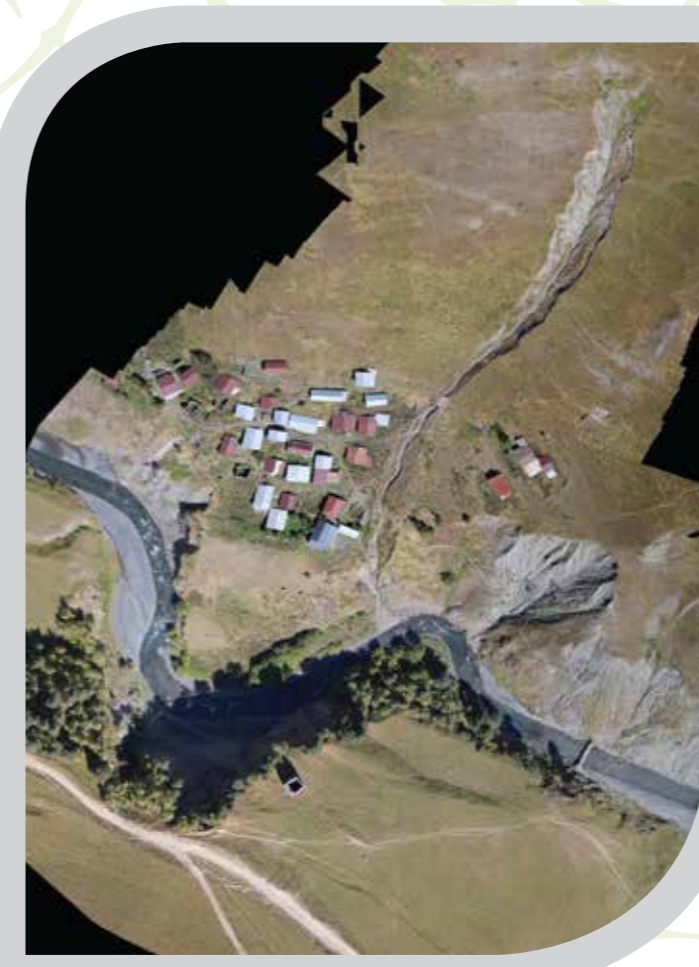
Photo 1: Jvarboseli rill from above (taken with a drone in 2016)

The unsustainable use of pastures and forest areas leads to erosion, degradation, desertification and loss of biodiversity in the high mountain regions of the South Caucasus. In the village of Jvarboseli, Tusheti, there is a significant gully directly above the western part of the village. This gully is the result of a severe landslide in 2004. The gully erosion itself starts at an elevation of 2010 m above sea level and extends all the way down to the village at an elevation of 1910 m. The total length of the gully is approximately 300 m.

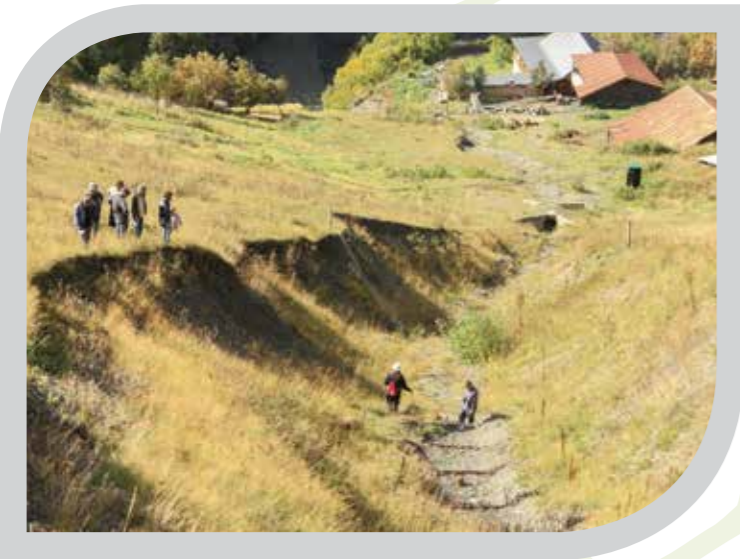
Gully erosion occurs when runoff water accumulates and rapidly flows in narrow channels during or immediately after heavy rains or melting snow, removing soil to a considerable depth.

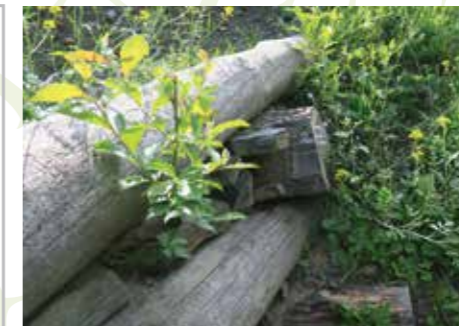
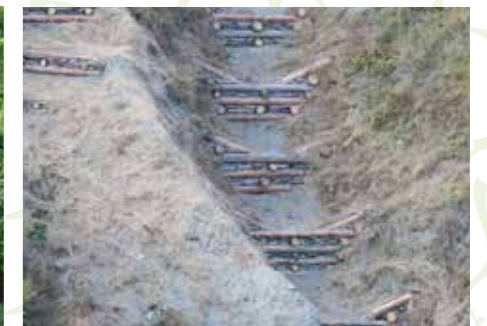
Vegetated wooden check dams are used as transverse structures for slope and bed stabilisation in steep gorges. The construction consists of three horizontal log-layers which were filled with drainage material; living branches or rooted woody plants were inserted into the side walls without blocking the discharge section. Locally available stones were used to prevent erosion of the wooden structure. The flowing water is being concentrated in the discharge section which is enforced by the shoulders of the structure to prevent alongside erosion processes.

In total, 14 vegetated check dams were built in section B and 11 in section C. The slope in section C was significantly steeper compared to the other sections. Therefore, although the general design of the check dams is similar, the structures in section C were built higher to obtain a balance slope. Additionally, three crib walls, check dams without wings, were built.

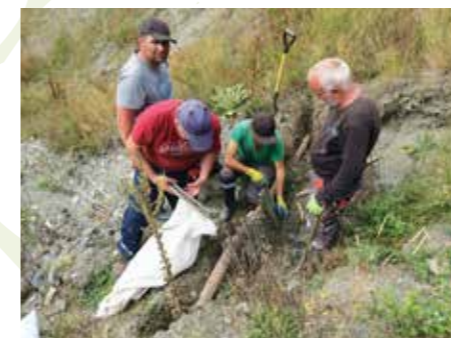
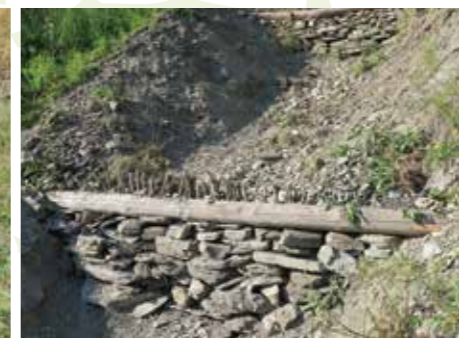
In the upper part of the gully, 13 vegetated palisades were constructed. These constructions work like the wooden check dams, but the dimensions are smaller. The construction material for one structure consists of a wooden log with a length of around 3.4 m and approximately 50 pieces of cuttings.

First an excavation was carried out to allow the positioning of the horizontal wooden log and its integration into the side areas. Then the willow cuttings were set vertically to reduce the slope. Finally, the vertical cuttings were filled with the excavated soil, and stones are put in front of the structure. The construction is very simple, with a height of around 60 cm, and suitable for smaller gullies with less load and flow.
