Integrated Biodiversity Management, South Caucasus

Synthesis Report on Erosion control measures 2014-2017

Azerbaijan

Report

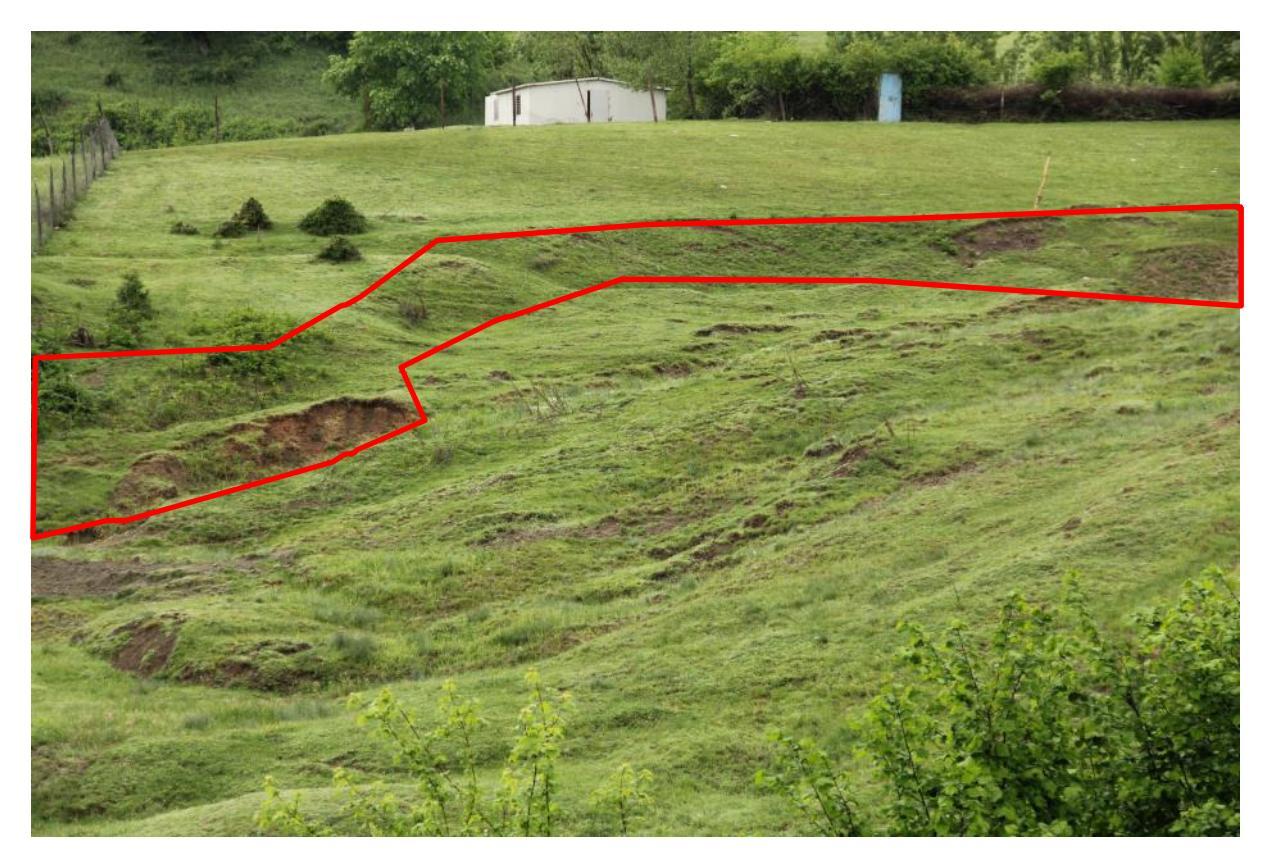
Sheet erosion on pasture land Hazelnut-hedges along contour-lines of slope 1.7 ha 2017 not started yet in 2017

Figure 1: The pasture on municipality land in Birinci Yeniyol shows sheet erosion caused by grazing and trampling. The red marked area is proposed for hazelnut hedges.

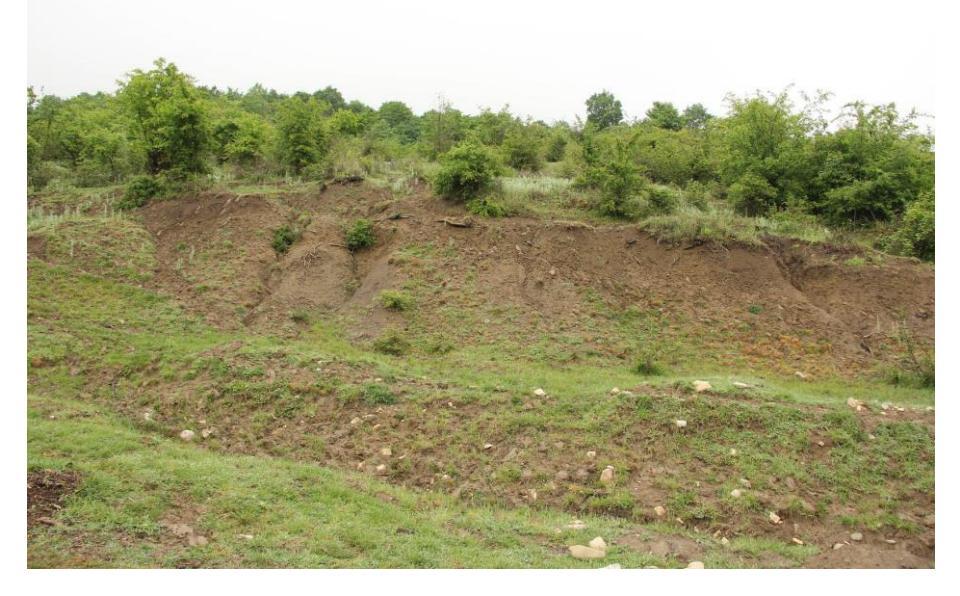
Figure 2: Steep eroded slope along the road to the village Birinci Yeniyol.

Planting of 170 m fruit tree hedge. Recommended is the establishment of a dense hedge on 170 m along the road, composed of fruit tree species and hazelnut shrubs. Wild plumb (*Prunus divaricata*), rosehip (*Rosa sp.*), Cornell cherry (*Cornus mas*) and walnut (*Juglans*) could be mixed with hazelnut.

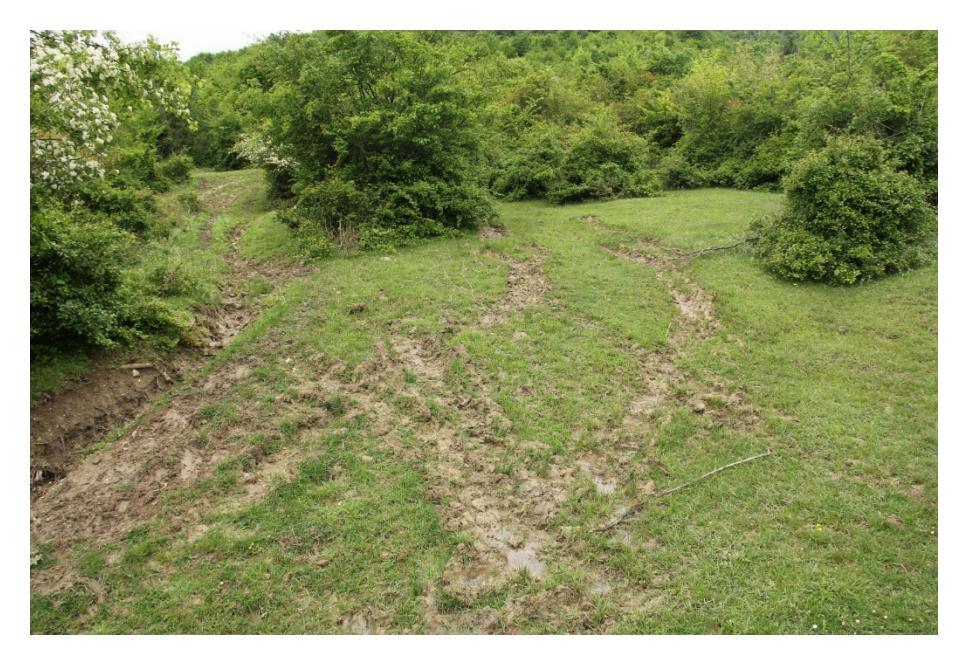
Figure 3: The pasture gets overgrown by shrubs, which leads to higher trampling on open areas.

Species, tools & planting scheme. About 30% of the site are steep and affected by erosion and therefore should be excluded from heavy grazing. The density of planted hazelnut shrubs on these areas should be 3x3m (1100 hazelnut/ha), resulting in **1600 hazelnut seedlings** for the entire pilot site in Diyalli. Appropriate tools for removing shrubs and maintenance of the area (**chain saw, brush-cutter, sickle bar mower**) are not only needed for the intervention area. These tools could help to improve pasture quality in the surrounding area as well, if this is included into a broader pasture/forest development program.

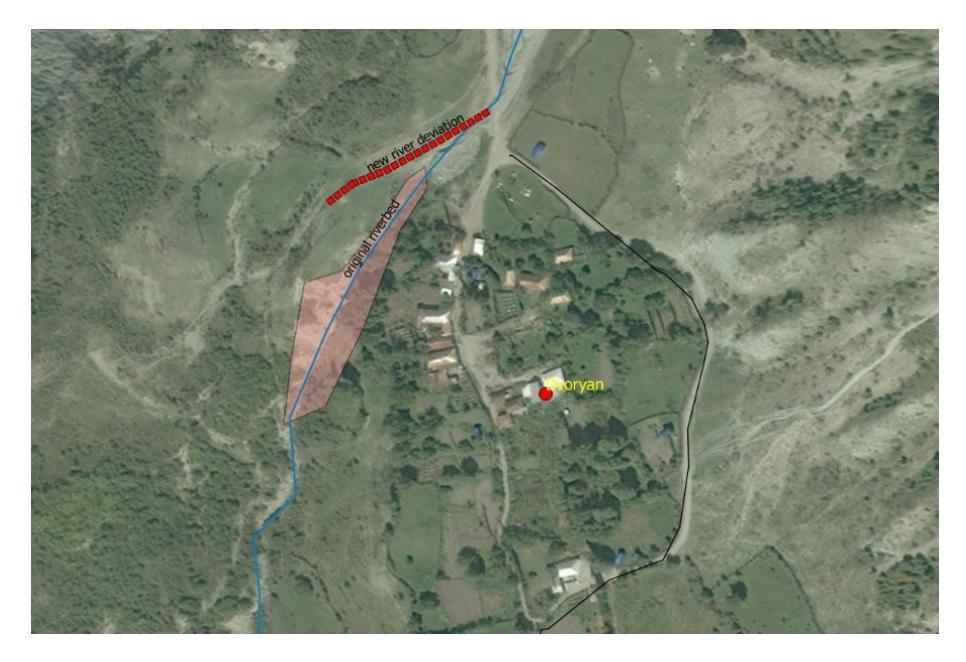
The river west of the village has created a deep gully-like riverbed. Heavy rainfalls in 2016 led to a deepening of the gully and to an undercutting of the slope right next to the village. Landslides reaching into house gardens was the result.

Figure 4: Natural hazard situation in Dvoryan village. The pink polygon is indicating the gully close to the houses.

As houses of the village are endangered, it is recommended to develop a comprehensive natural hazard plan. It would need technical engineering competence to calculate water catchment, extrapolation of high water events and to develop appropriate technical solutions for protection of the village.

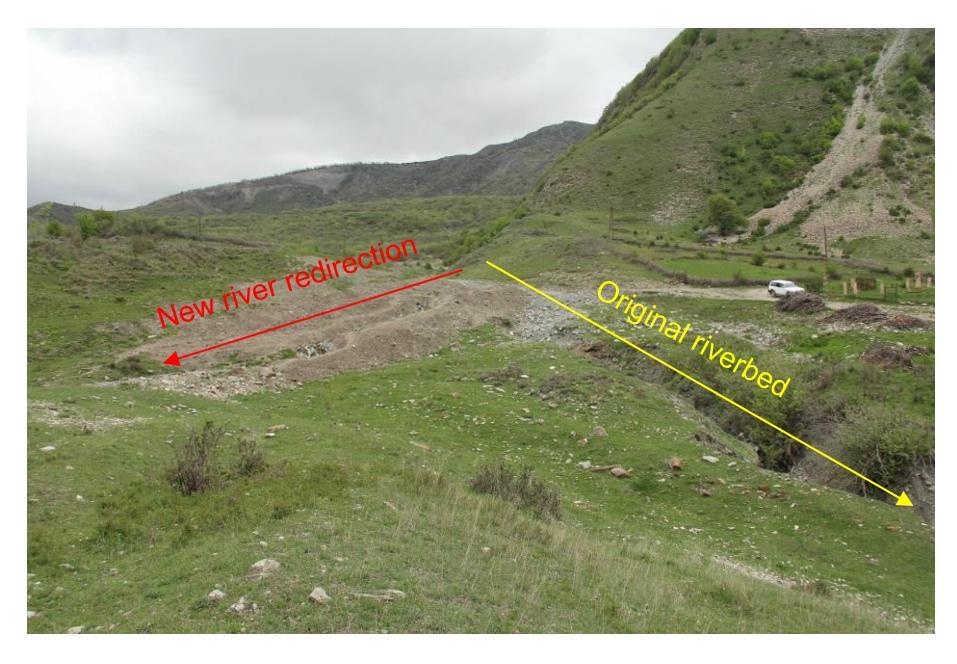
To reduce the high risk of a continued deepening of the gully and further landslides threatening the settlements, the original water flow was changed by villagers to a more south-western direction.

Technical engineering. Currently, the redirection of the water is realized through a simple dam built from gravel material (1 m height, 2-3 m width). In the case of heavy rainfalls, it is very likely that the dam would not withstand the erosive power of the water and that the river would return to its old riverbed.

Figure 5: River re-direction in Dvoryan village.

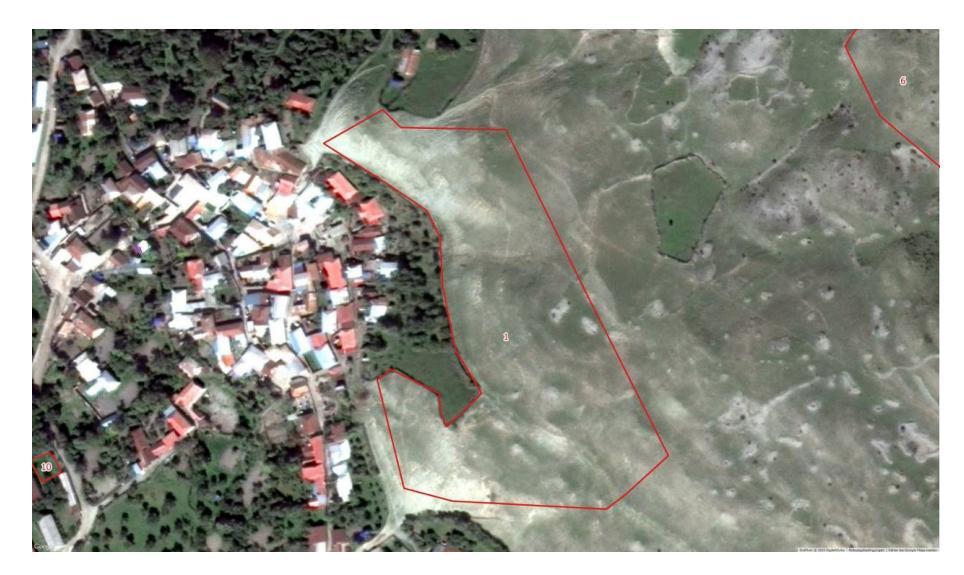
Heavy sheet erosion on steep pasture land Stabilisation of erosion on steep slope above the village (pile walls, fencing, hedge-rows) 2.8 ha 2015

Figure 6: Site 1 is located north-east above the village Ehen.

The objective of the measures are (1) rehabilitation of the vegetation cover on the steep slope and (2) reduction of the risk of rock fall by horizontal hedges and tree rows.

<u>Measure 1: Fencing</u>: A permanent fence (needed at least 10 years) has to be established to avoid further degradation by livestock. The total length will be 620 m and three gates for passengers are needed.

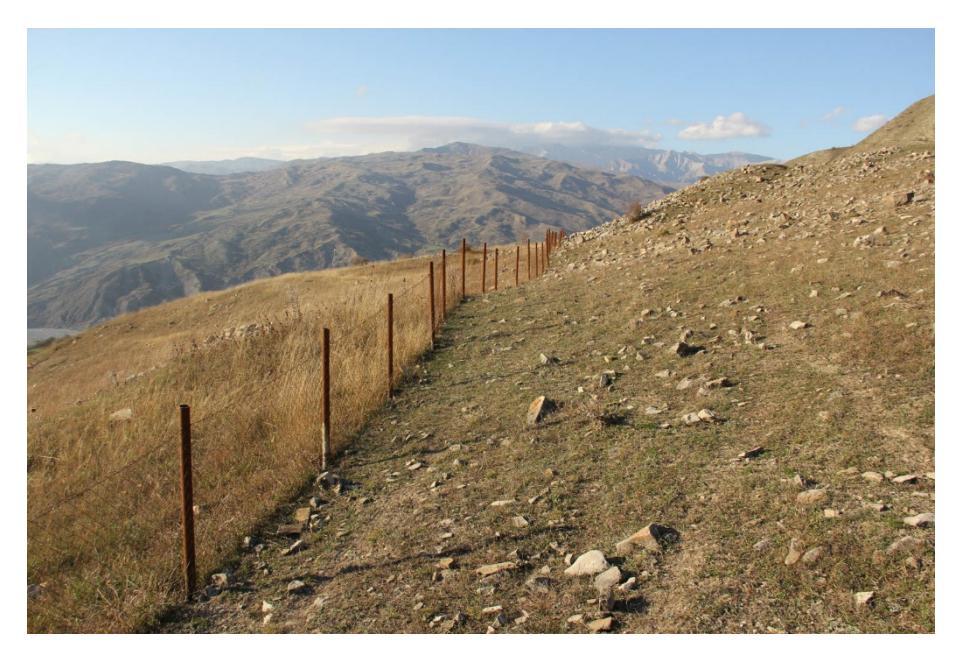
<u>Measure 1: Fencing</u>: The permanent fence is installed. The exclusion from grazing has significantly improved the vegetation biomass and vegetation cover.

Figure 7: Ehen site 1. Current state of fence and vegetation improvement in Nov. 2017.

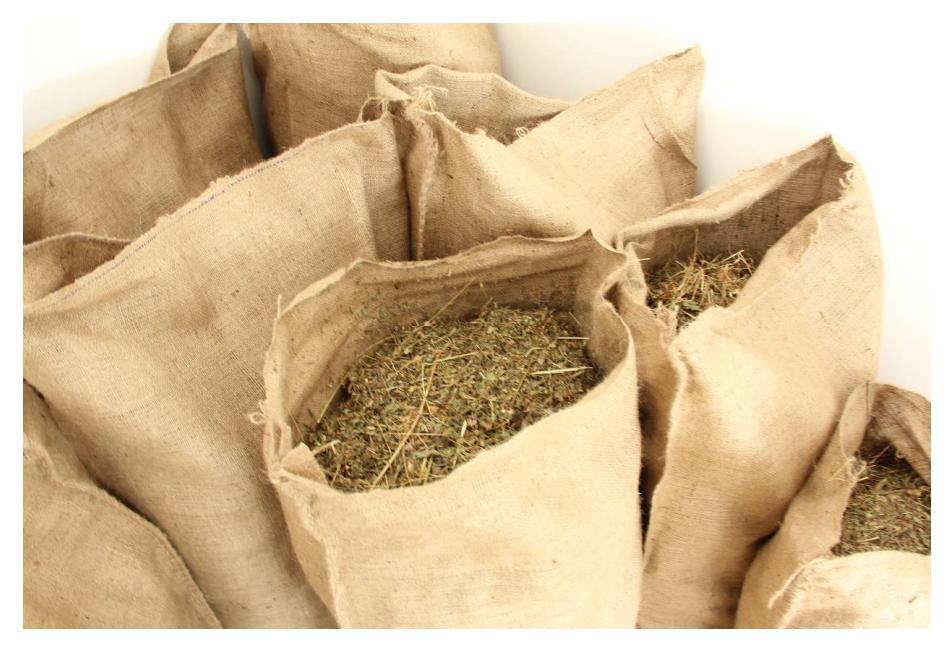
<u>Measure 3: Application of hay residuals and hay mulching</u>: On four test-plots of 10 x 10 m the application of hay residuals and hay mulching has been piloted in autumn 2016. One year later, in November 2017, the hay mulch was still visible, while the smaller pieces of the hay residuals were mostly washed away. Hence, the hay mulch provides a good physical protection against sheet erosion caused by the impact of raindrops. The hay cover allows that more moisture is kept by the soil and germination of seeds can be observed.

Figure 8: Local hay residuals collected from farmers in Ehen in autumn 2016.

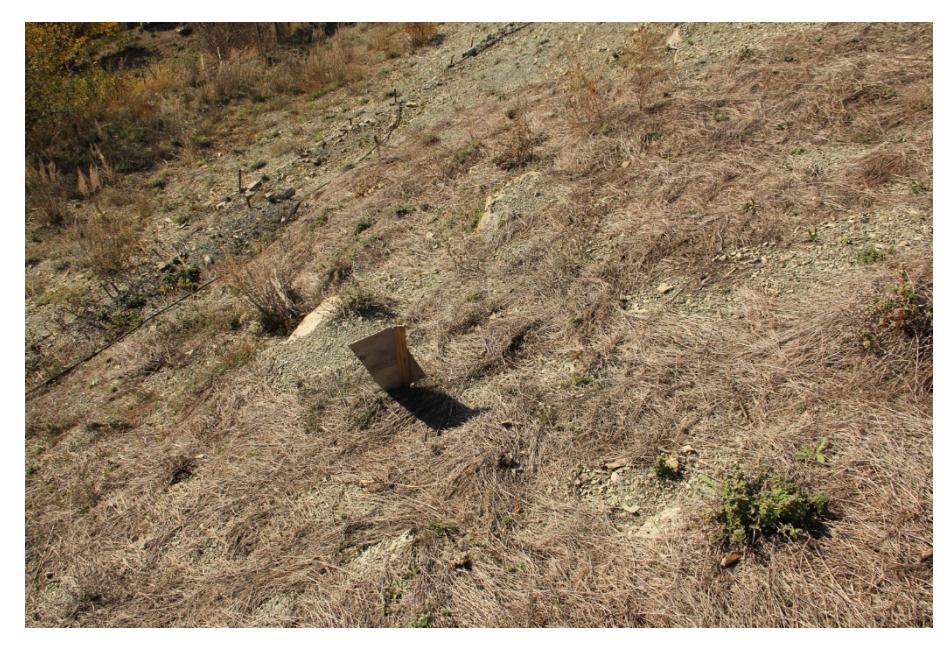
Figure 9: Hay mulch test site in Nov. 2017 one year after application.

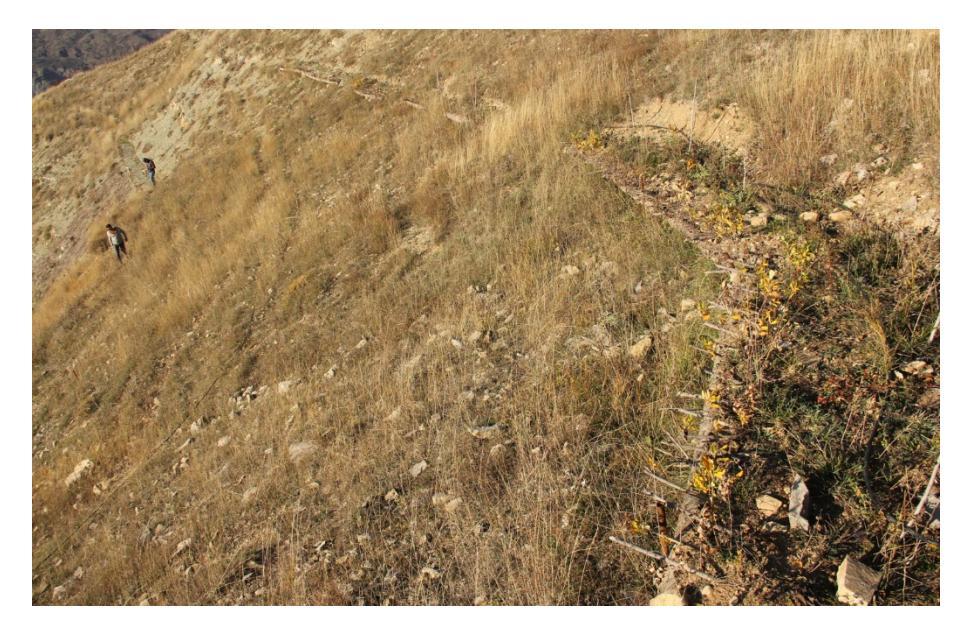
The pile wall system was constructed in autumn 2016. Only 3.2 m (instead of 4m) long wooden post with diameter of 12-17cm have been available. A drip irrigation system was installed. In November 2017, it was visible that the willow cuttings profiting from the irrigation system show significantly higher survival rates than those without irrigation. Another observation was, that willow cuttings with less than 2 cm diameter (thumb-like) have significantly lower survival rates than those with diameters of 2-4 cm. On the terraces, walnut and oak trees have been planted which show high survival rates when irrigated.

Figure 10: Pile walls on site 1 in Nov. 2017.

As timber cannot be extracted from the local forests, availability and up-scaling potential of the measure is limited. Adaptation of legal regulations to extract local timber for erosion control measures would be helpful.

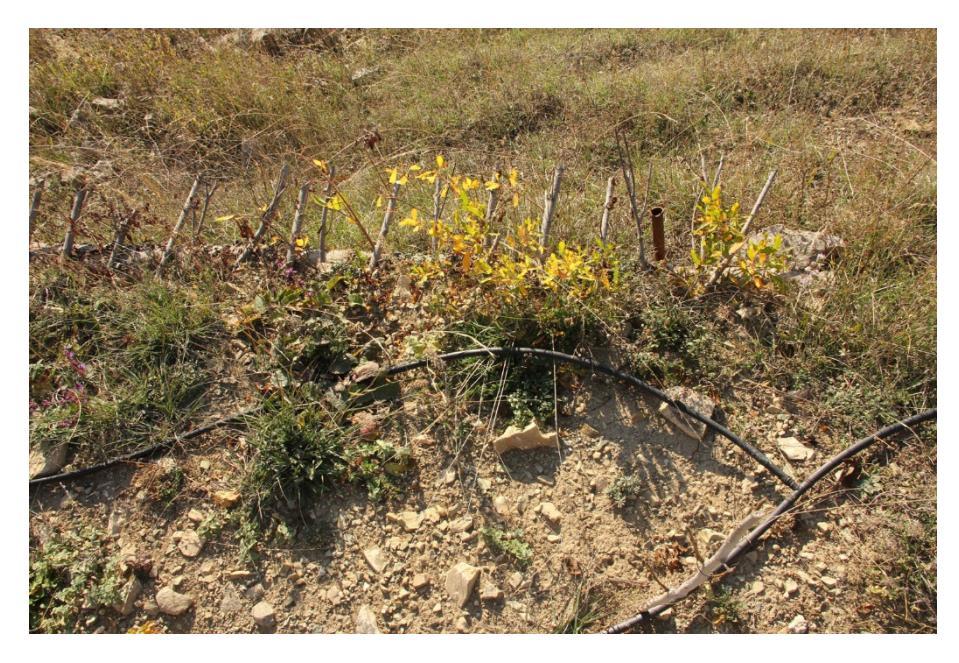
Figure 11: Sprouting willows with irrigation system on a pile wall (Nov. 2017).

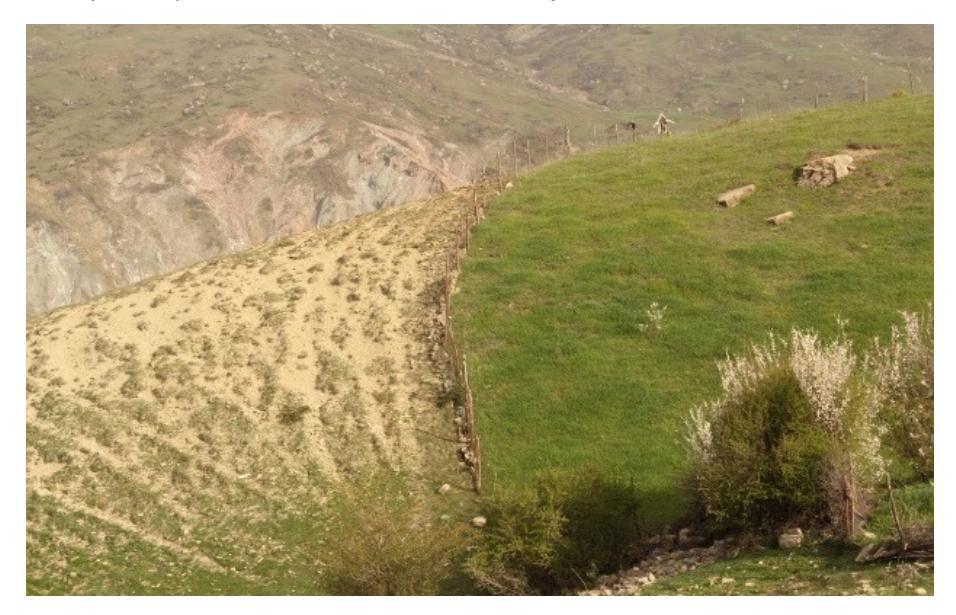
Figure 12: Pasture and hay meadow on the same site conditions showing significant difference in erosion at site 3.

Fencing. The eroded parts should be fenced in a first step.

Application of hay residuals/hay mulch. In order to support the rehabilitation of vegetation, hay residuals as described under site 1 should be applied. On some very exposed areas, the hay residuals need to be covered by jute/coconut nets to avoid immediate removal by wind or heavy rain (see recommendations on hay residuals and coconut net above).

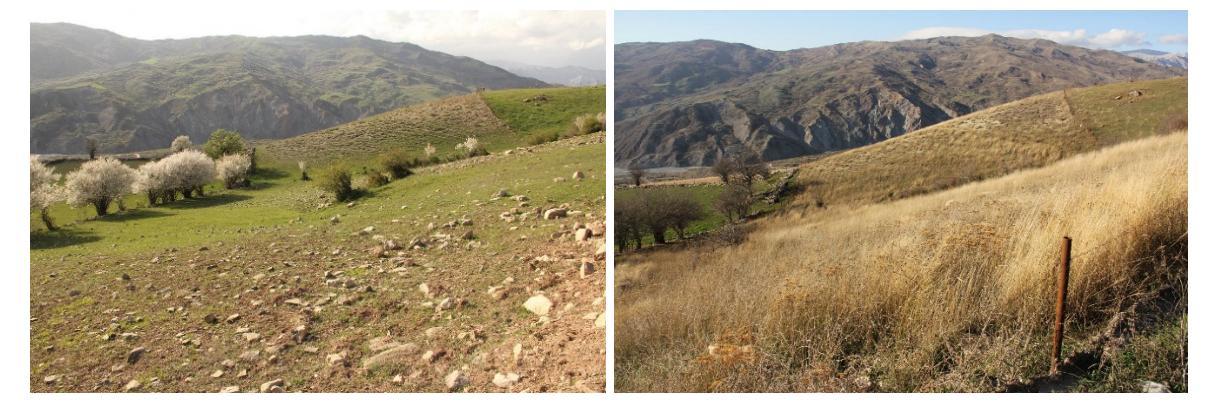
In summer 2016, site 3 and 4 were fenced and hay residuals and hay mulch have been applied in autumn 2016. The fence is showing a positive impact on the vegetation cover and biomass (see comparison in Figure 13). Site 4 might be already use for hay production in 2018. The productivity of this site could be significantly increased through the removal of stones and an active control of the water run of from the road (which washes down the stones). An open question remains the land use-rights (hay harvesting) for the community land.

Figure 13: View from the road across site 4 to site 3 in the background. Left April 2015, right Nov. 2017.

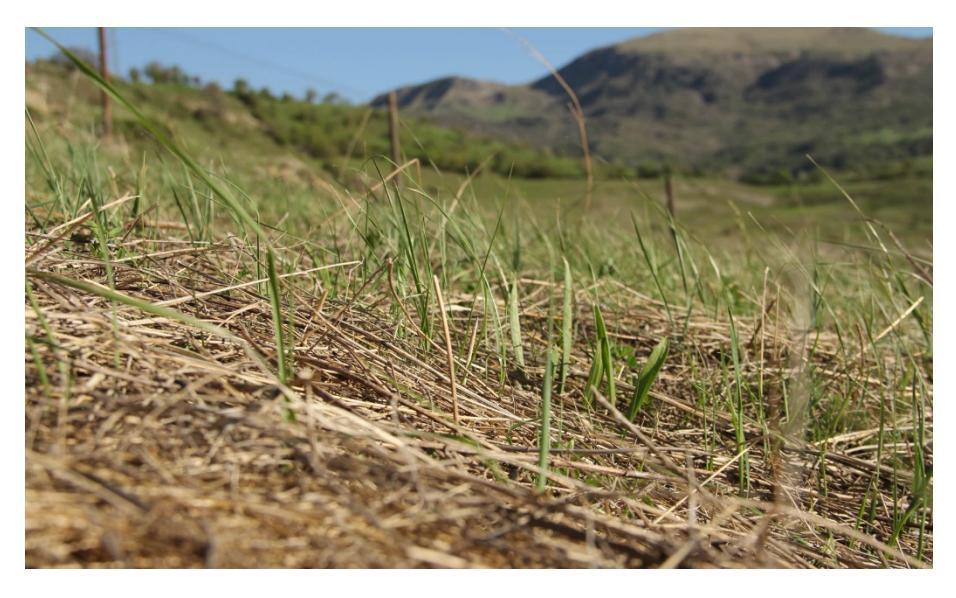
The western ridge (site 3, in the background of figure 14) shows more biomass after fencing, but due to the minimal humus layer and the low soil fertility, regeneration of vegetation is limited. On this site, the hay-mulching test plot shows better results than the application of hay residuals, which seem to be washed away quite quickly on slopes > 5°. The hay mulch supports the retention of moisture and supports germination of local herbs and grasses.

Figure 14: new plants germinating under the hay mulch layer (May 2017).

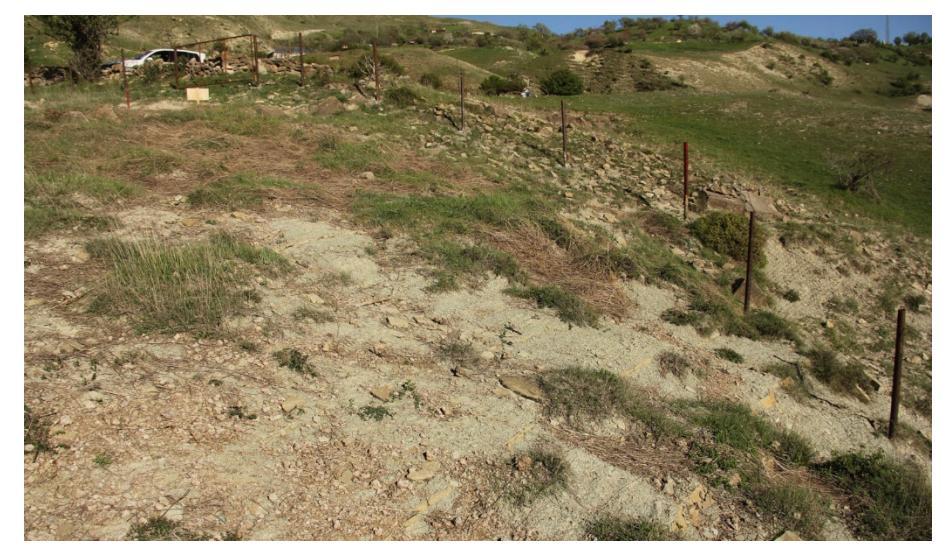
Figure 15: Test plots for hay-residuals in the front and hay mulch in the back.

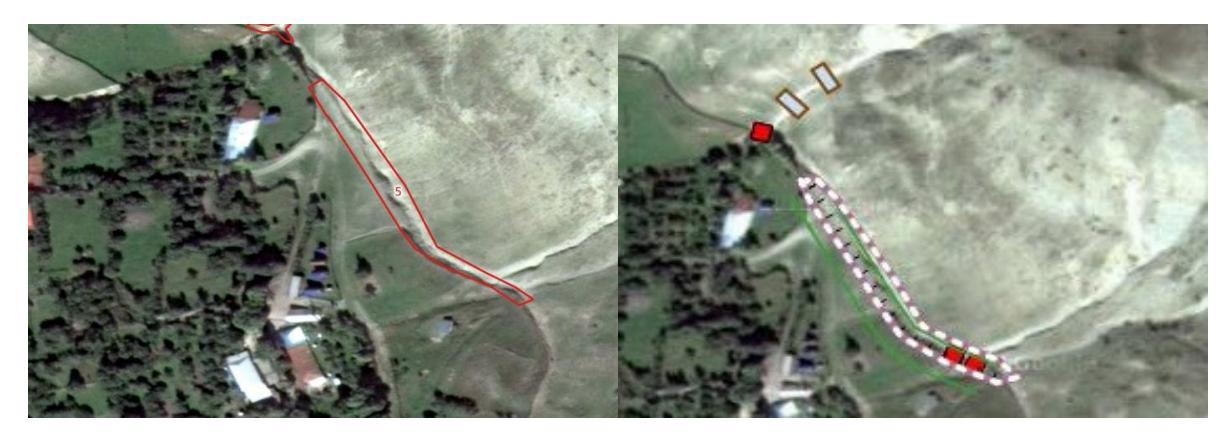
Establishment of a hedge along the trench. Above the north-western part of the village a trench was constructed to channel the water run-off from the hillside and to stop stone fall. With the planting of a hedge, the effectiveness and durability of the trench shall be enhanced.

Heavy gully erosion above road Tree/shrub hedge for stabilisation of trenches 0.1 ha 2015

Figure 16: Site 5 is located north of the village along a trench system to prevent stone fall and flooding.

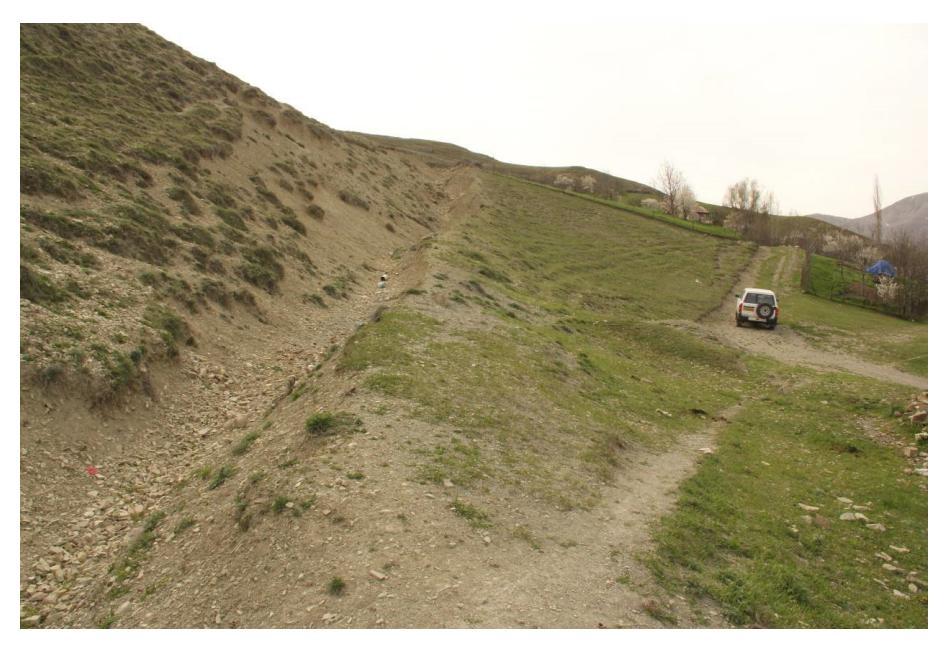
Figure 17: Situation of the site 5 in April 2015.

<u>Measure 1: Temporary Fencing</u>: To establish tree and shrub vegetation, a temporary fencing (electric fence; 5-8 years) is needed to avoid browsing by livestock (especially from goat). Trees and shrubs should only be planted on one side of the trench (towards the road) but the fence should also cover the opposite slope to foster natural vegetation rehabilitation.

<u>Measure 2: Planting of a tree or shrub row:</u> A row of trees and shrubs stabilizing the edge of the trench on the downhill side should be planted. Trees should be planted in October 2016 to avoid damage by summer drought.

<u>Measure 3: Arming of trenches by gabions:</u> in the eastern part of the trench two gullies are connected in a 90° angle. The impact of the water flow on the opposite part of the trench should be limited by two gabion arming.

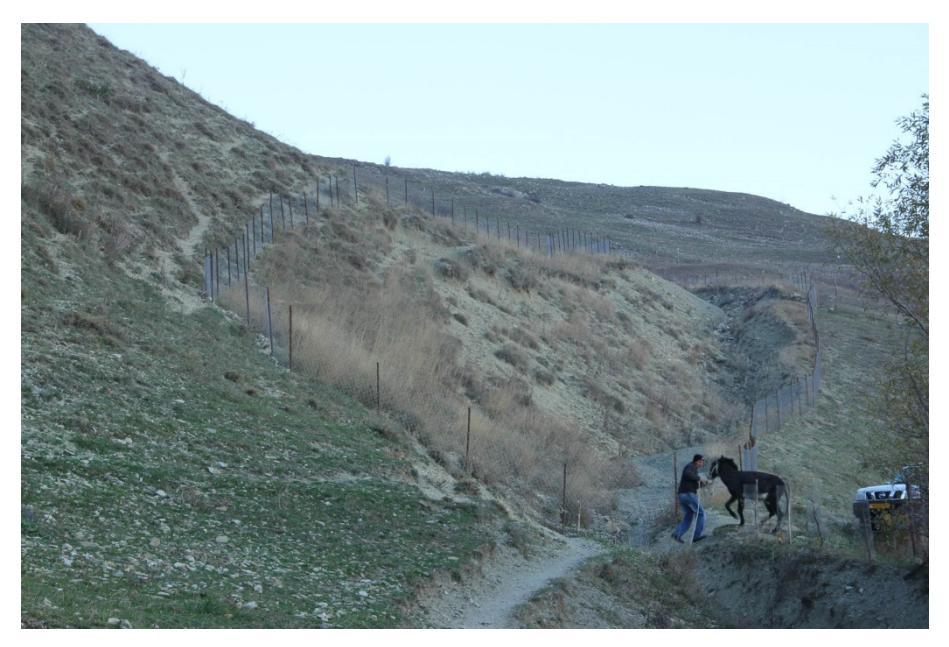
<u>Measure 1: Temporary Fencing</u>: As electric fence was not available a mesh-wire fence was established to exclude livestock from the sensitive area.

Figure 18: Established fence on site 5 (Nov. 2017).

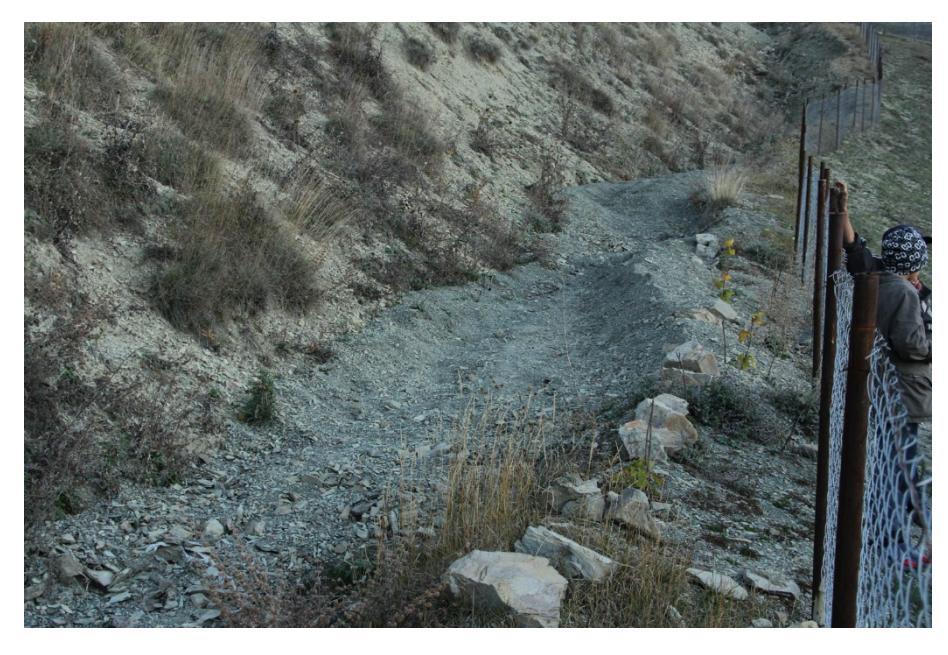
<u>Measure 2: Planting of a tree or shrub row:</u> A line of trees were planted inside the fence. Most of them were still alive in November 2017.

Figure 19: Trees planted on lower part of the trench inside the fence on site 5 (Nov. 2017).

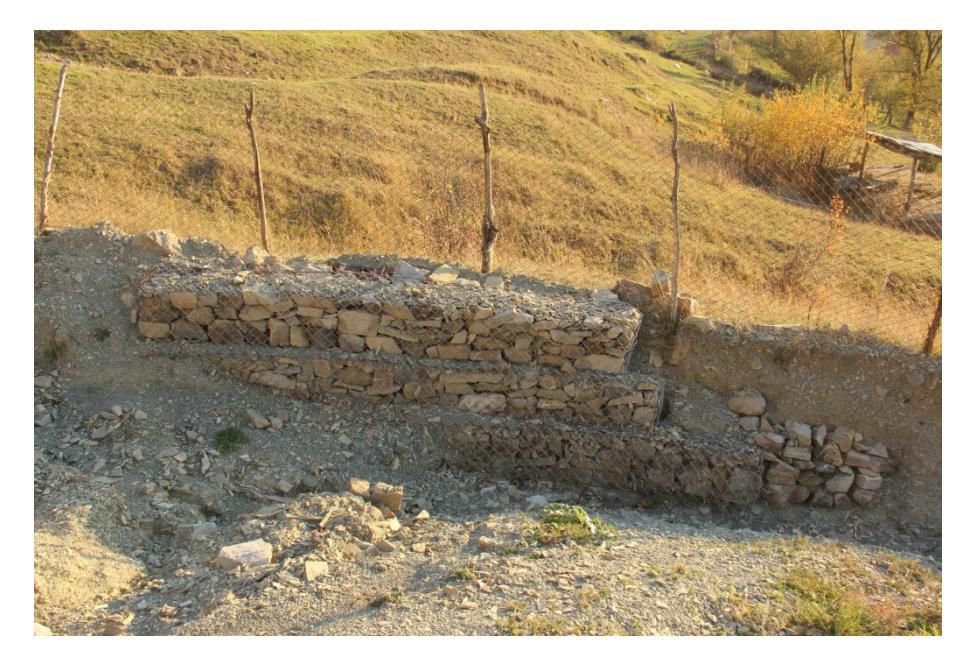
<u>Measure 3: Arming of trenches by gabions:</u> The gabion arming was installed in summer 2017. Two layers of gabion arming 0.5x0.5 m and 5 m length have been placed at each of the gully-mounting places.

Figure 20: Gabion arming on site 5 (Nov. 2017)

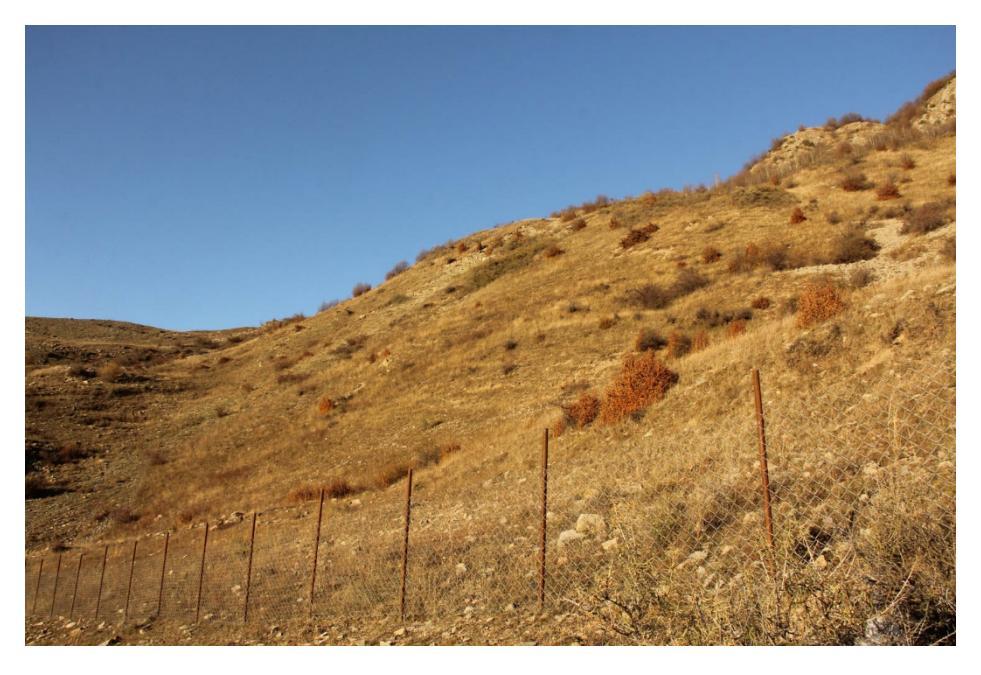
The seedling survival rate was around 50%, which is still good under the harsh conditions of this very dry site. Acer and Oak have the highest survival rates in those areas, as observed in November 2017. Drip irrigation is not possible on this slope

Figure 21: Site 6 in Ehen in November 2017.

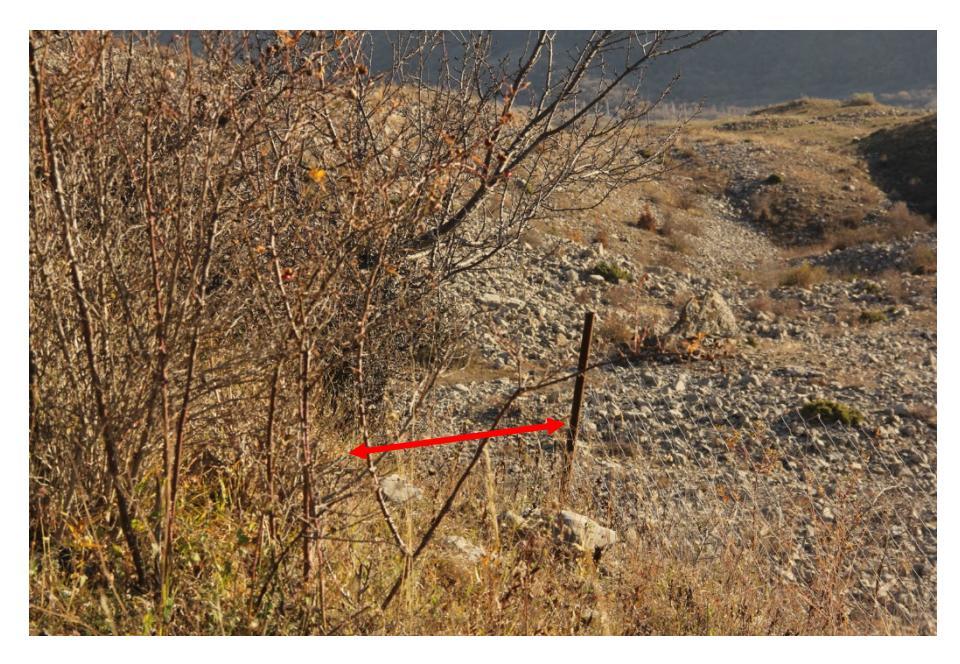
The fence is not surrounding the whole plot, as the upper part is only hardly accessible, and it is unlikely that livestock will invade from above. Only on the eastern part, a few meters of fence are missing to make it even more inaccessible. It seems that still some goats are entering the afforestation site, but there was no sever damage of seedlings so far. Existing shrubs and trees are showing positive responses to the fencing by increased number and length of this year's sprouts. The seedlings have not been planted in the proposed group scheme but are randomly distributed within the mosaic of open soils, stone fields and groups of shrubs.

Figure 22: At the east side of the fence there is a gap of 2-3m where livestock can enter the afforestation site.
